Fractographic Inspection of the
Cracking FT488/2 Removed at
Program 79

DSTO-TN-0170

**Airframes and Engines Division
Aeronautical and Maritime Research Laboratory**

During the inspection of the FT488/2 Bare Bulkhead Fatigue Test specimen after 79 blocks of applied loading, cracking was found in several wing-attachment hole aft edges. Each of the cracked regions of the holes was cut from the bulkhead, sixteen of the cracks were broken open and the exposed crack surfaces were analysed. This analysis revealed several interesting aspects of fatigue crack growth in this bulkhead. These included the nature of the most (in this case) significant initiating flaws, the type (compared to other thick 7050 plate material) and effect of the microstructure on the growth of these cracks, and the relative growth rates of these cracks including estimates of the number of programs to failure.

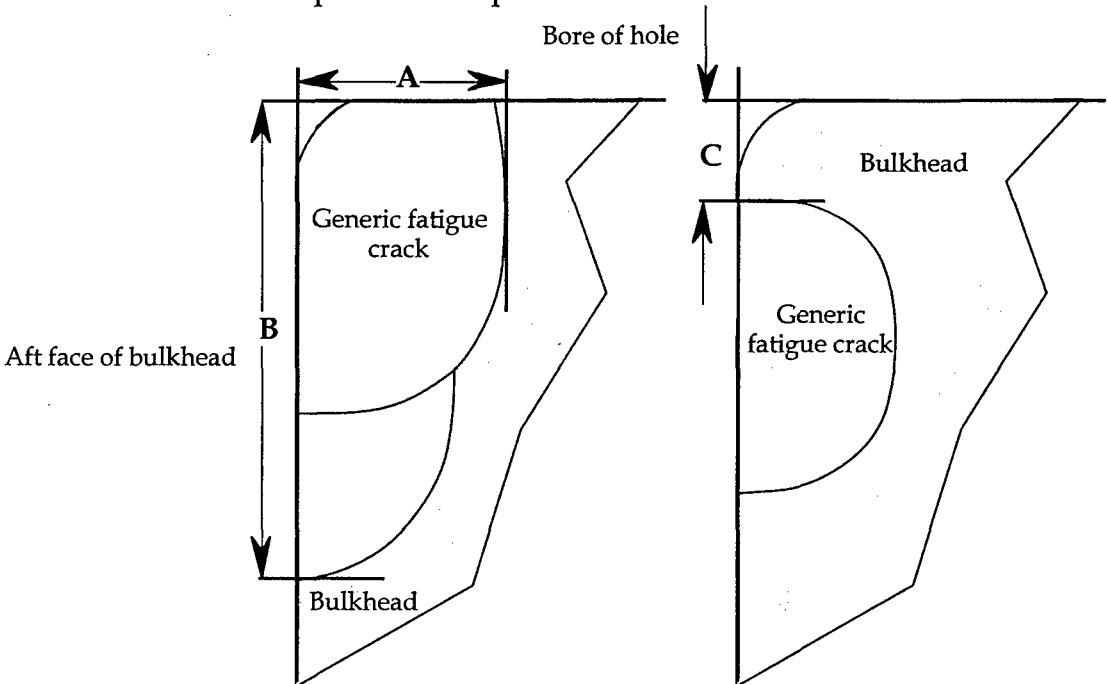
As each crack was opened the dimensions set out in Table 1 were taken. These figures refer to the dimensions marked in the schematics Figure 4.

Figure 4. Schematics of the fatigue crack types showing the positions of the dimensions presented in Table 1

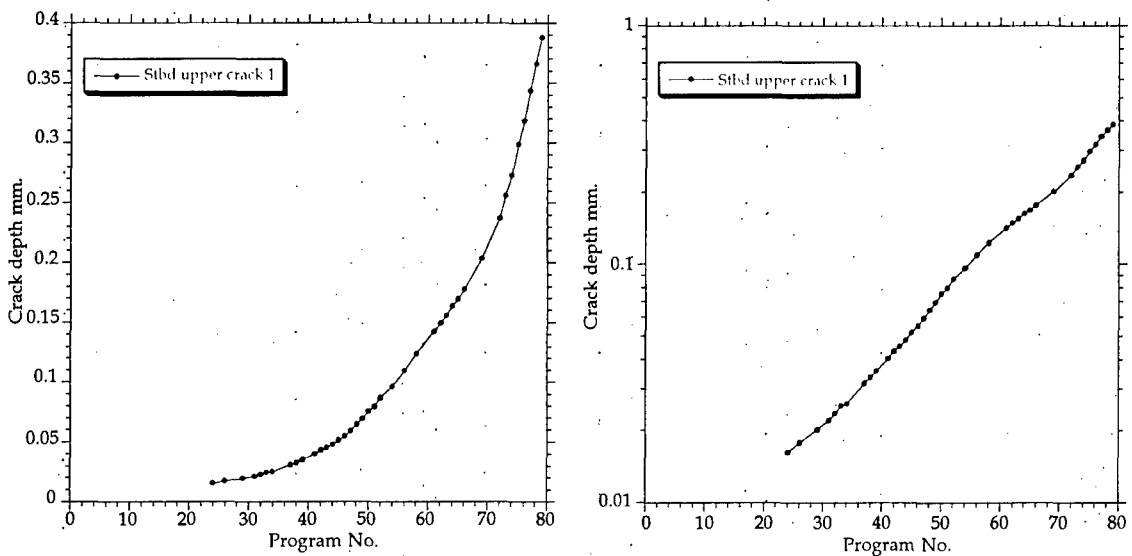
Figure 6. Two plots showing the results of quantitative fractography. Plot A - linear crack depth versus Program No. and B - crack depth on a Log scale versus linear Program No.

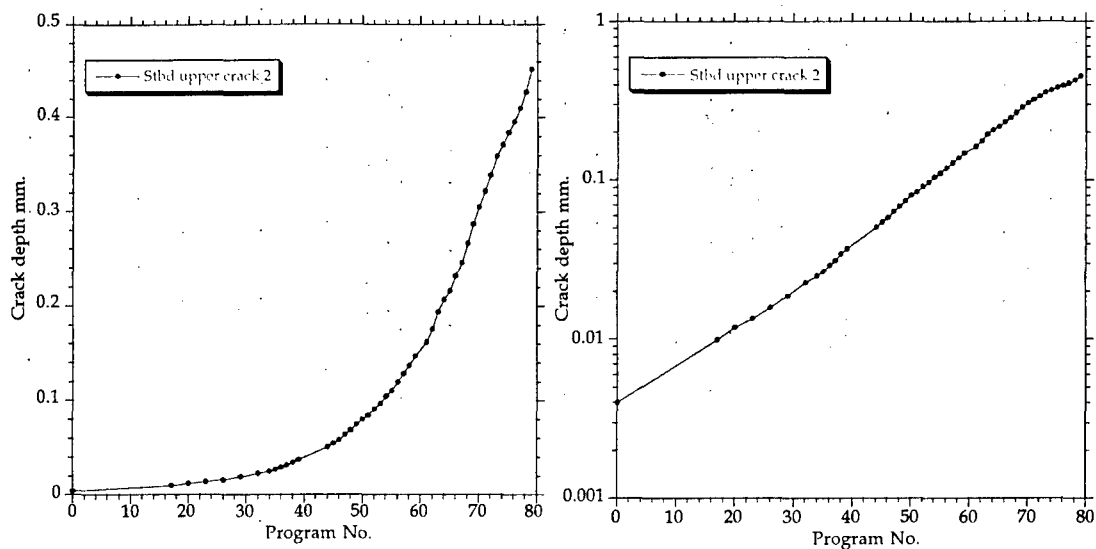
Figure 8. Two plots showing the results of quantitative fractography. Plot A – linear crack depth versus Program No. and B - crack depth on a Log scale versus linear Program No

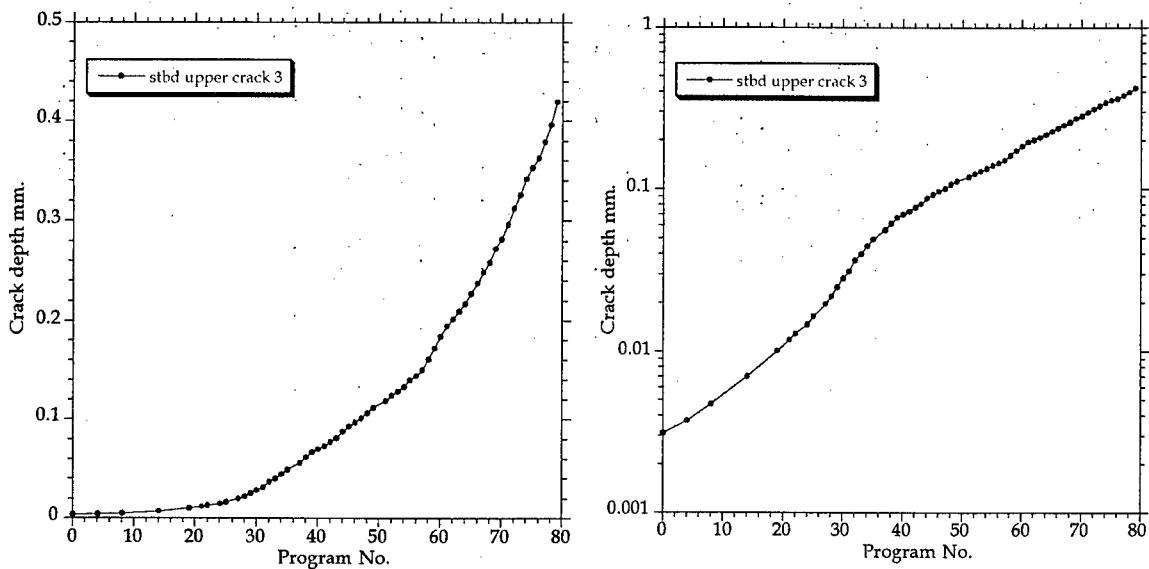
Figure 10. Two plots showing the results of quantitative fractography. Plot A – linear crack depth versus Program No. and B – crack depth on a Log scale versus linear Program No.

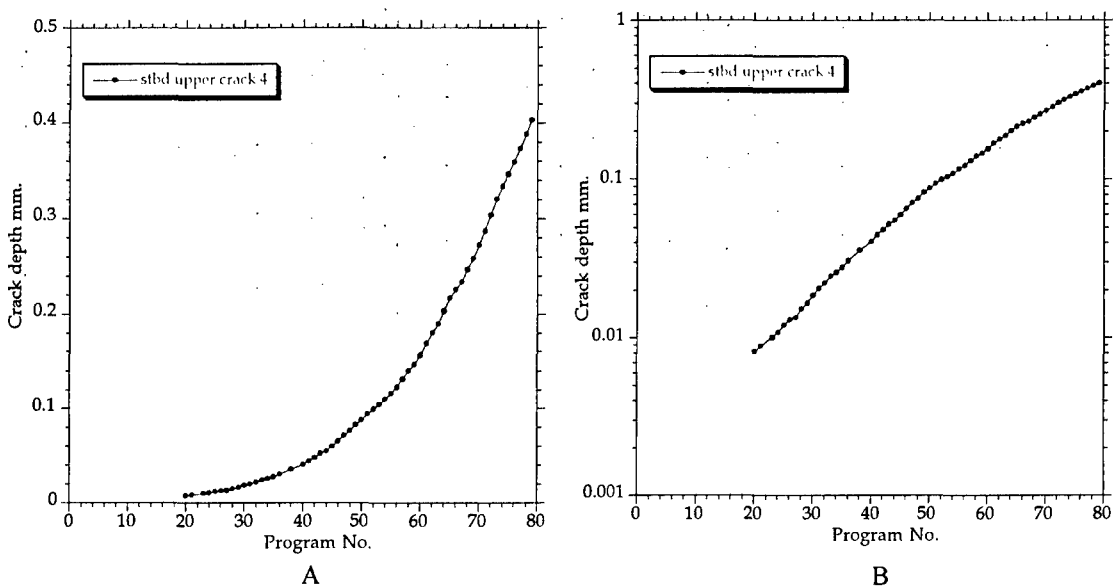
Figure 12. Two plots showing the results of quantitative fractography. Plot A – linear crack depth versus Program No. and B - crack depth on a Log scale versus linear Program No.

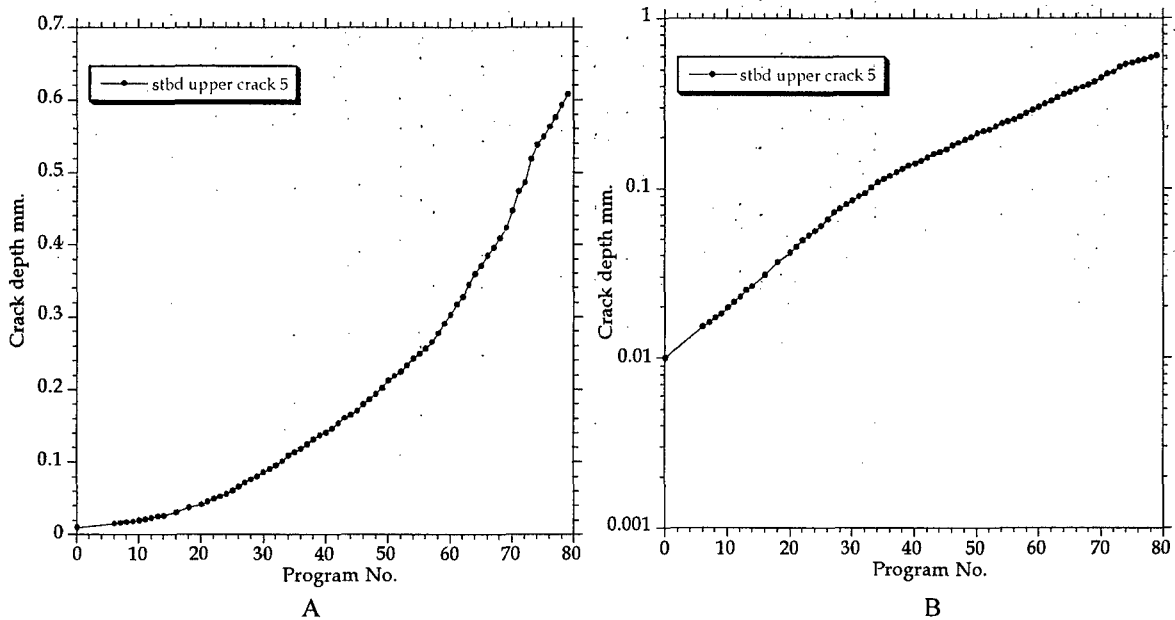
Figure 14. Two plots showing the results of quantitative fractography on crack 5. Plot A – linear crack depth versus Program No. and B – crack depth on a Log scale versus linear Program No.

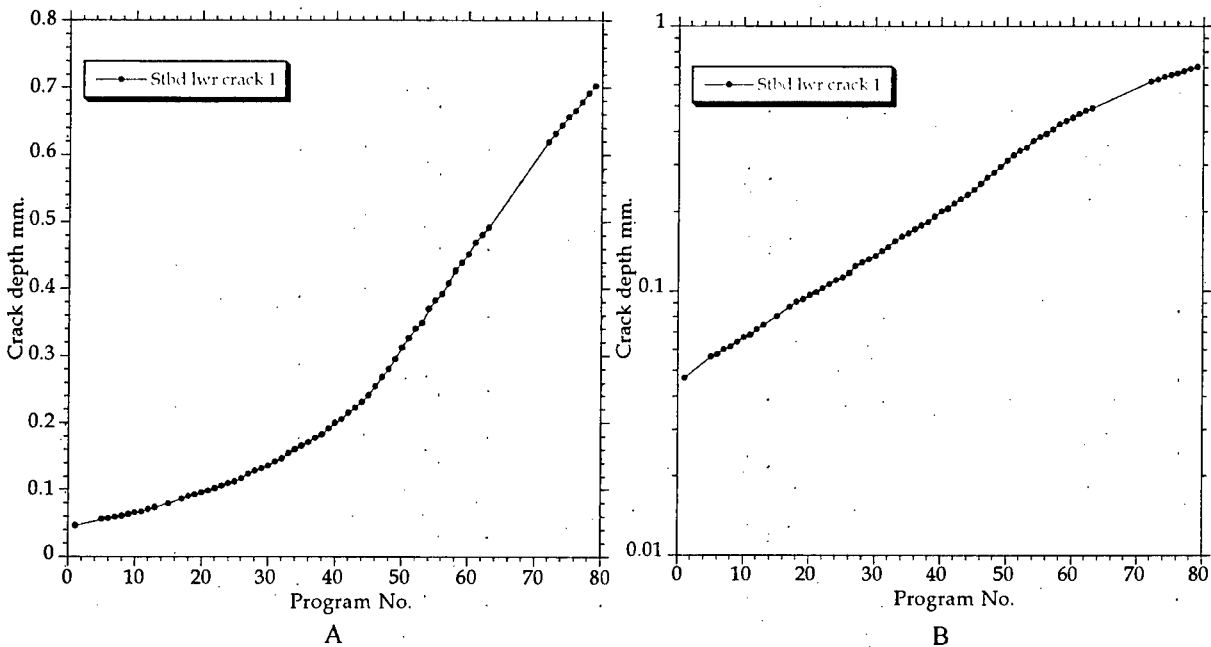
Quantitative fractographic examination gave the results as set out in Figure 17. The nature of the lip precluded estimating the flaw size, although an examination of the growth as depicted by the fractography indicates that the 'effective initial crack' size was about $45\mu\text{m}$. Although it is possible that the damage, and therefore the crack initiation, occurred some time after the start of the test, the fractography suggest that it occurred very early, if not at the start of the test. Some residual stress effect may have been present as evidenced by the slight change in the slope of 'B' in Figure 17, although this effect must have been small.

Figure 17. Two plots showing the results of quantitative fractography on crack 1. Plot A – linear crack depth versus Program No. and B – crack depth on a Log scale versus linear Program No.

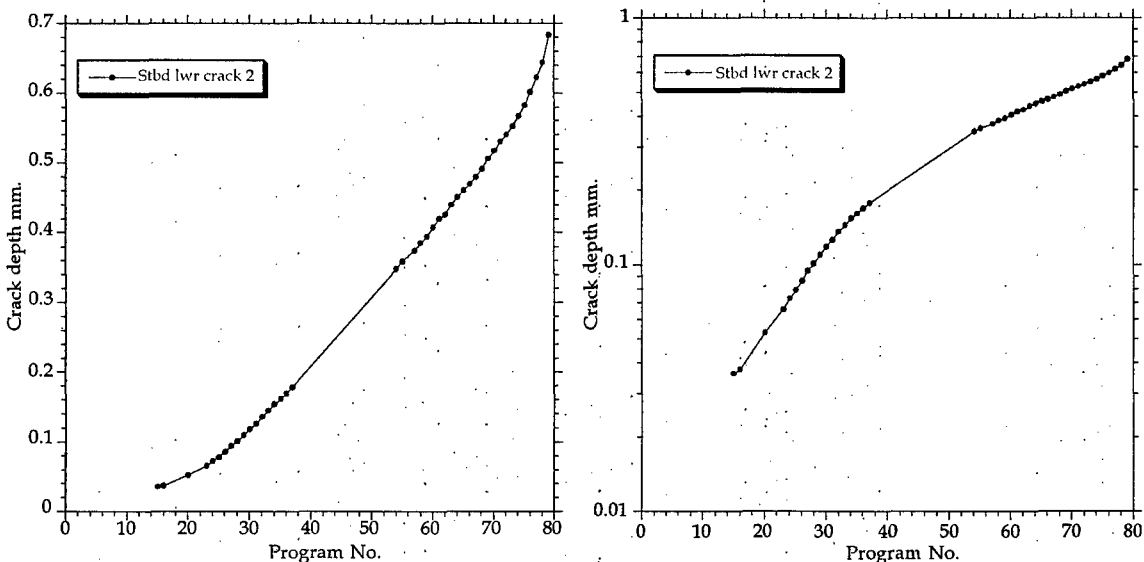
Figure 19. Two plots showing the results of quantitative fractography. Plot A - linear crack depth versus Program No. and B - crack depth on a Log scale versus linear Program No.

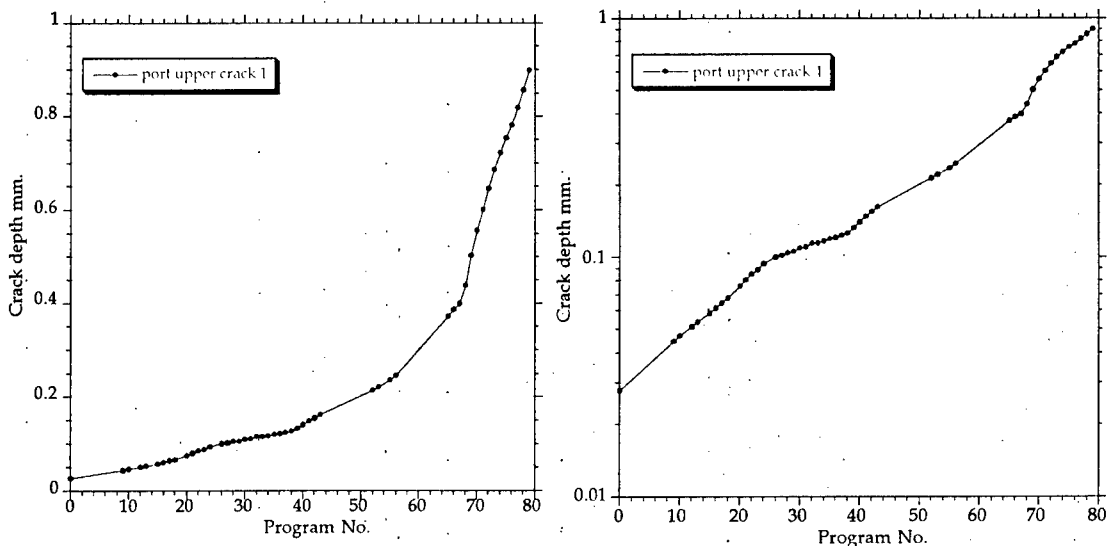
Figure 21. Two plots showing the results of quantitative fractography. Plot A – linear crack depth versus Program No. and B - crack depth on a Log scale versus linear Program No.

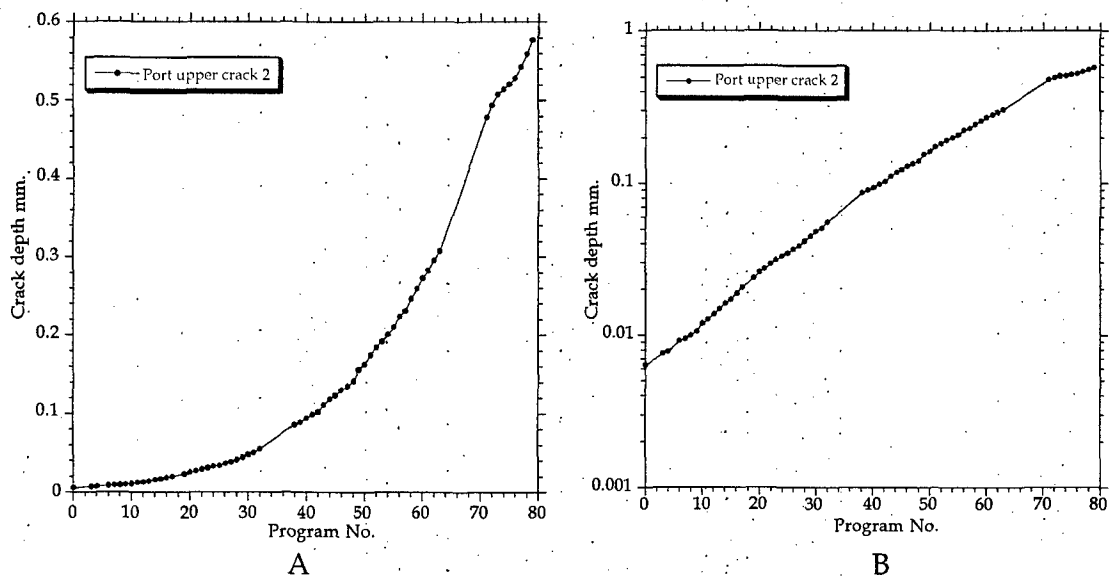
Figure 22. Two plots showing the results of quantitative fractography. Plot A - linear crack depth versus Program No. and B - crack depth on a Log scale versus linear Program No.

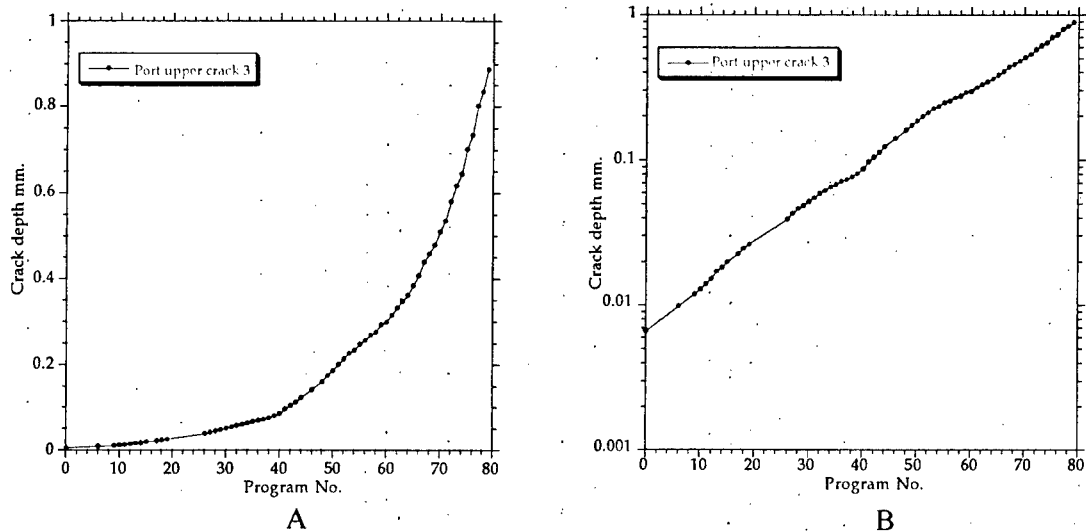
Figure 24. Two plots showing the results of quantitative fractography. Plot A - linear crack depth versus Program No. and B - crack depth on a Log scale versus linear Program No.

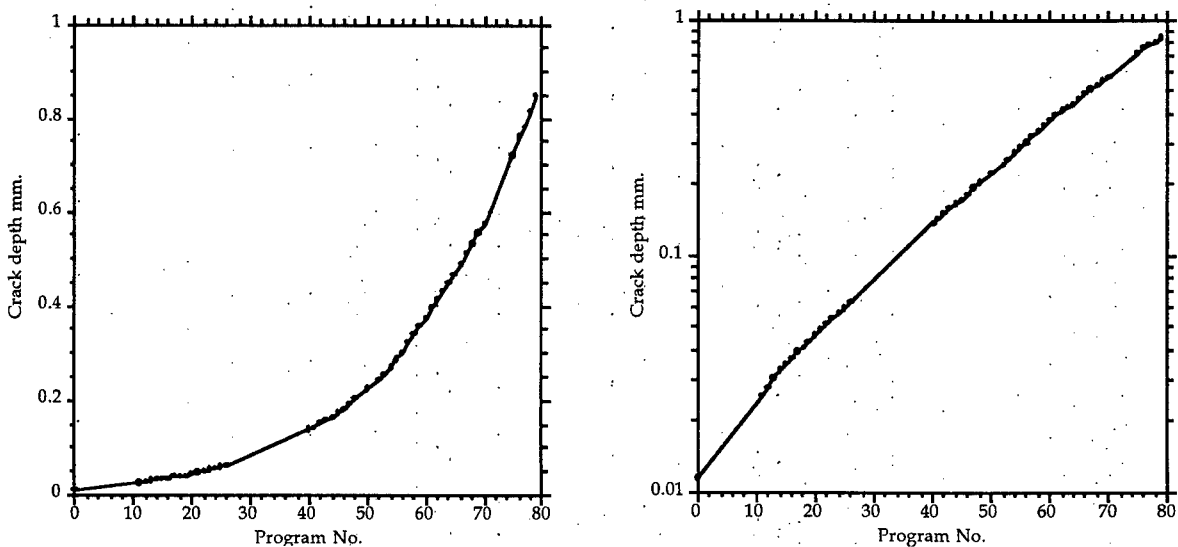
Figure 26. Two plots showing the results of quantitative fractography of crack 4. Plot A - linear crack depth versus Program No. and B - crack depth on a Log scale versus linear Program No.

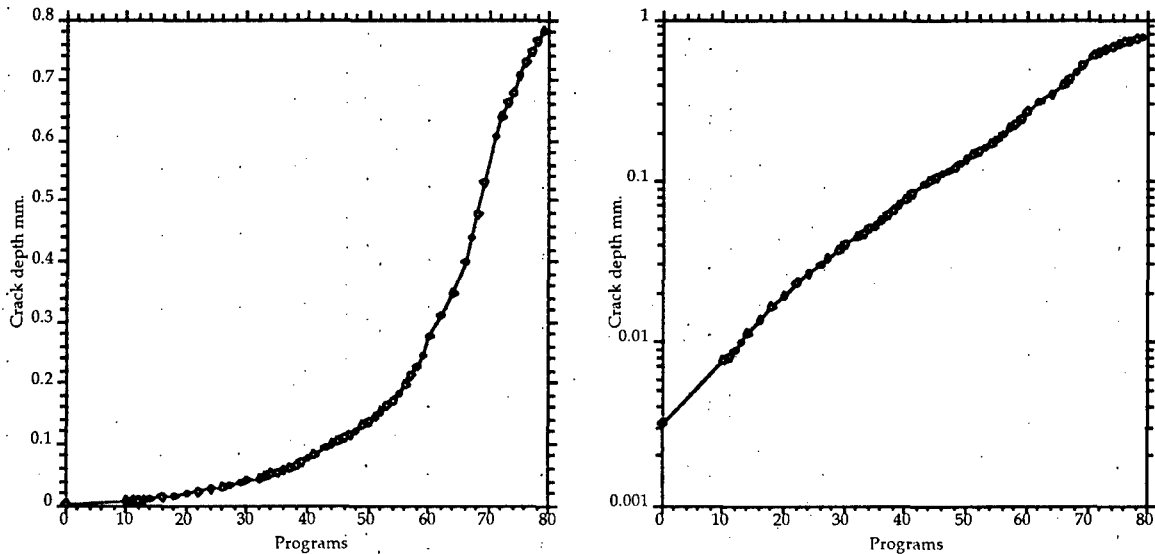
Figure 28. Two plots showing the results of quantitative fractography. Plot A - linear crack depth versus Program No. and B - crack depth on a Log scale versus linear Program No.

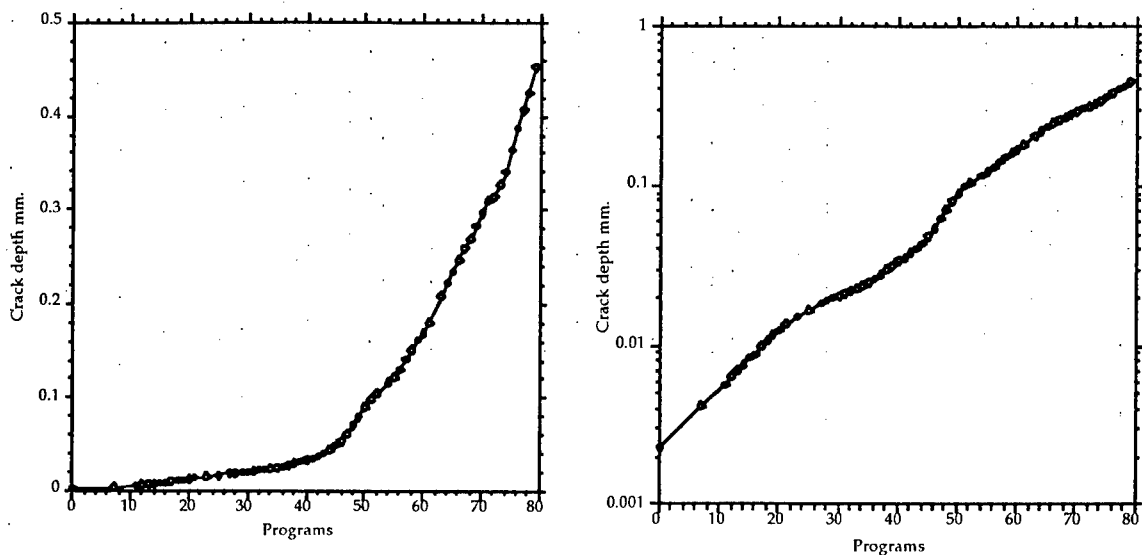
Figure 30. The quantitative fractography results. Plot A – linear crack depth versus Program No. and B - crack depth on a Log scale versus linear Program No.

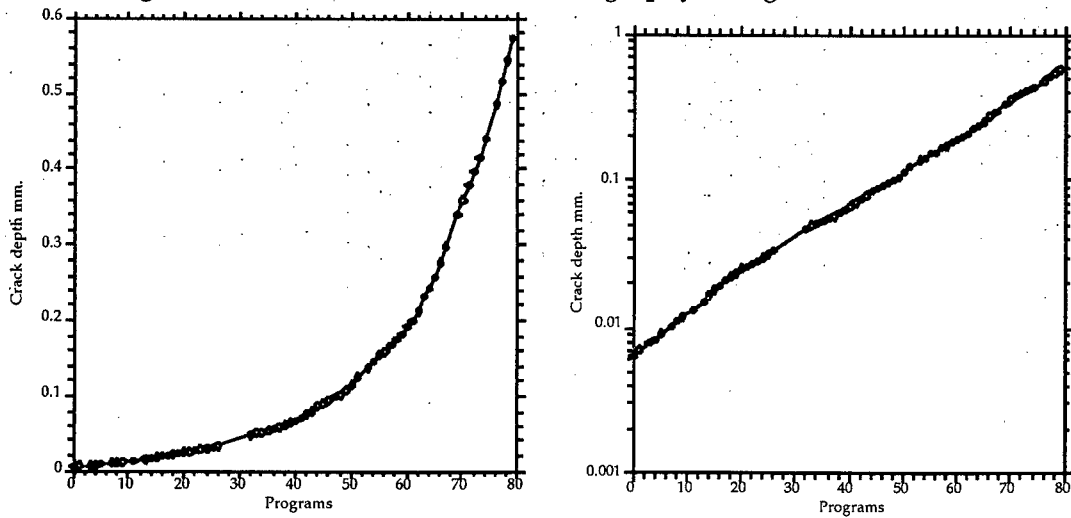
Figure 32. The quantitative fractography results. Plot A – linear crack depth versus Program No. and B - crack depth on a Log scale versus linear Program No.

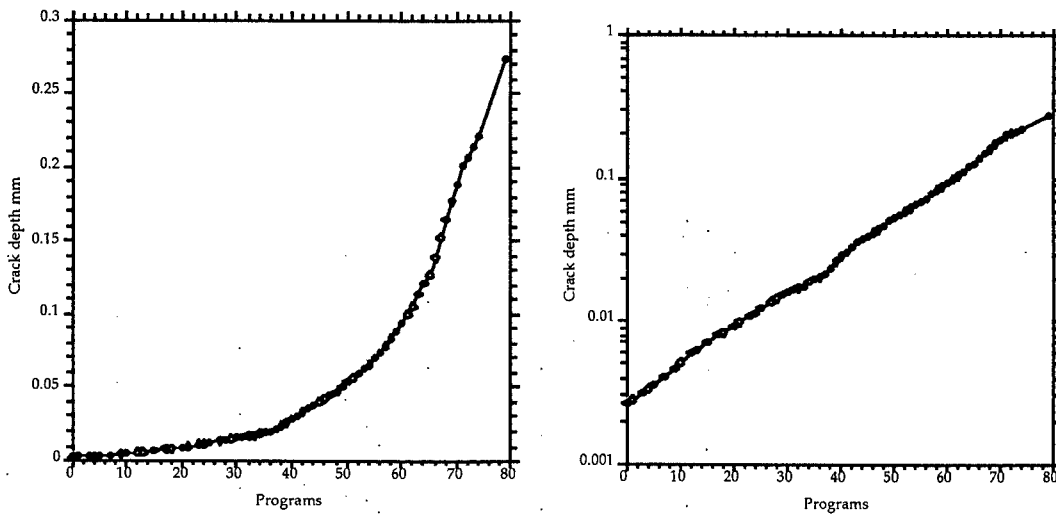
Figure 33. The quantitative fractography results. Plot A – linear crack depth versus Program No. and B - crack depth on a Log scale versus linear Program No.

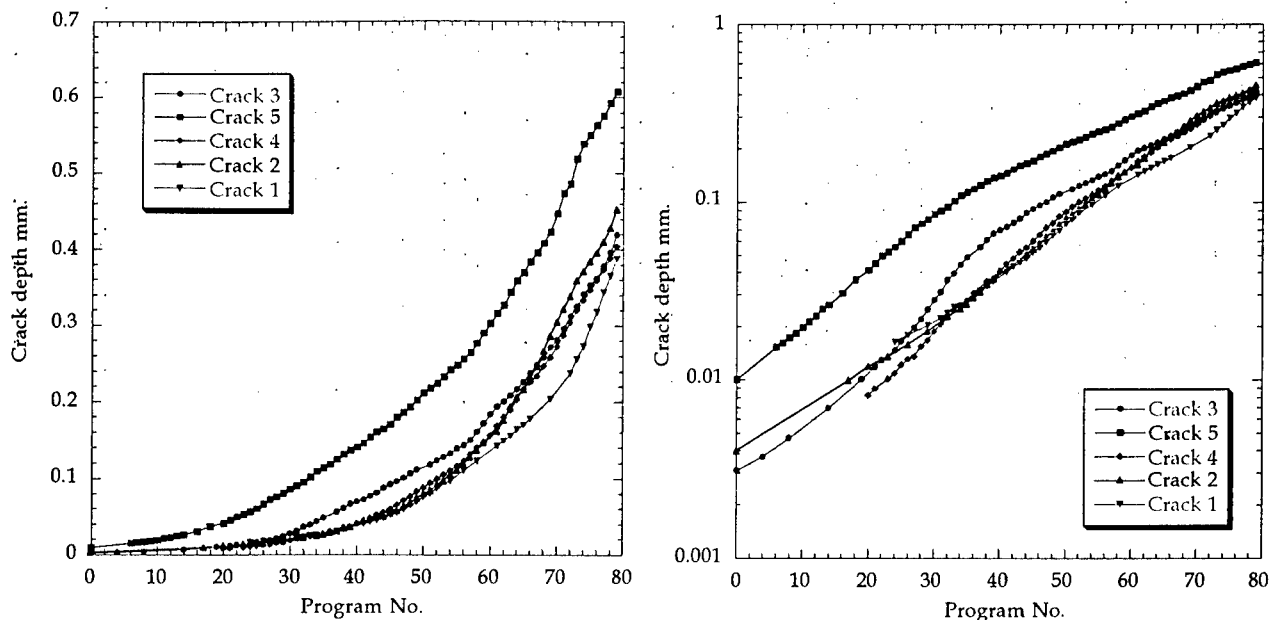
Quantitative fractography of several cracks from each of these two holes were carried out. Summaries of the crack growth curves produced are presented in Figure 41 and 42. The crack growth data was plotted using log/linear axes in Figure 42, as this procedure has been found to reduce the data towards a straight line. This procedure was based on observations of a large number of program loaded fatigue tests [4] as well as data from service fatigue cracking, previous 488 bulkhead tests and numerous 7050 six inch radius fatigue tests using several different spectra [4, 5, & 6]. All of the curves produced in this analysis were found to show reasonably consistent results. The crack growth in most cases did approximate a straight line between depths of about 10µm to 1mm when plotted on a log/linear scale. (Such straight-line behaviour is similar to the constant-amplitude loading case where crack growth is a function of $(\Delta K)^2$) [5 & 6].

Figure 41 A plot of the growth of the cracks from the starboard upper wing-attachment hole

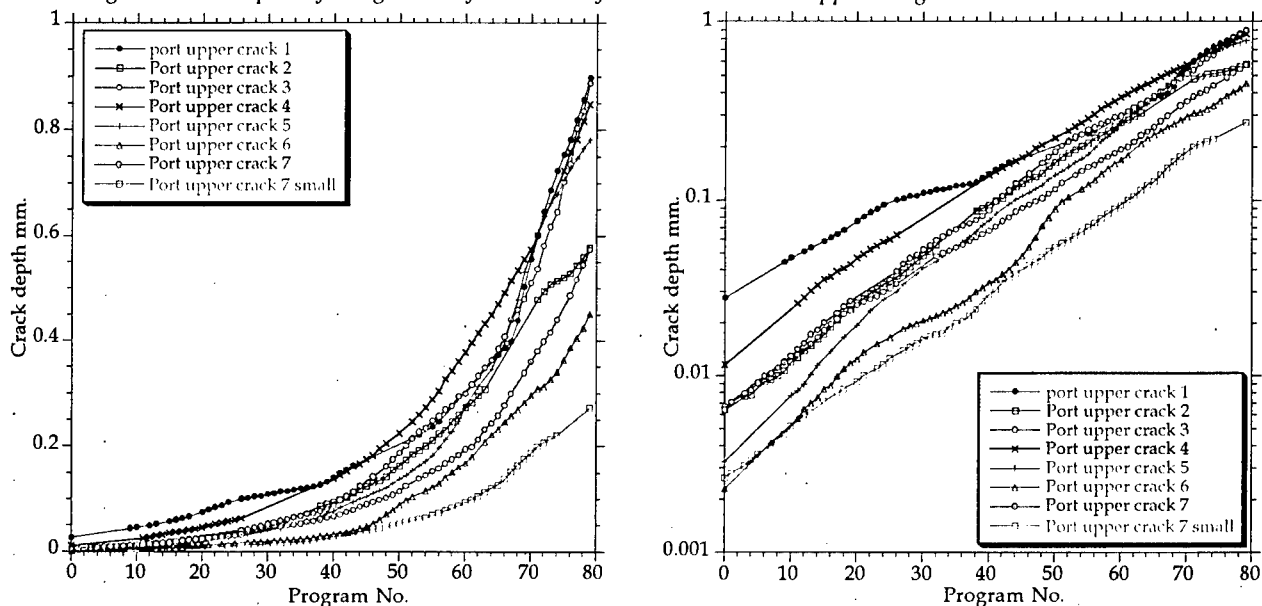
Figure 42 A plot of the crack growths from those cracks examined from the port upper wing-attachment hole

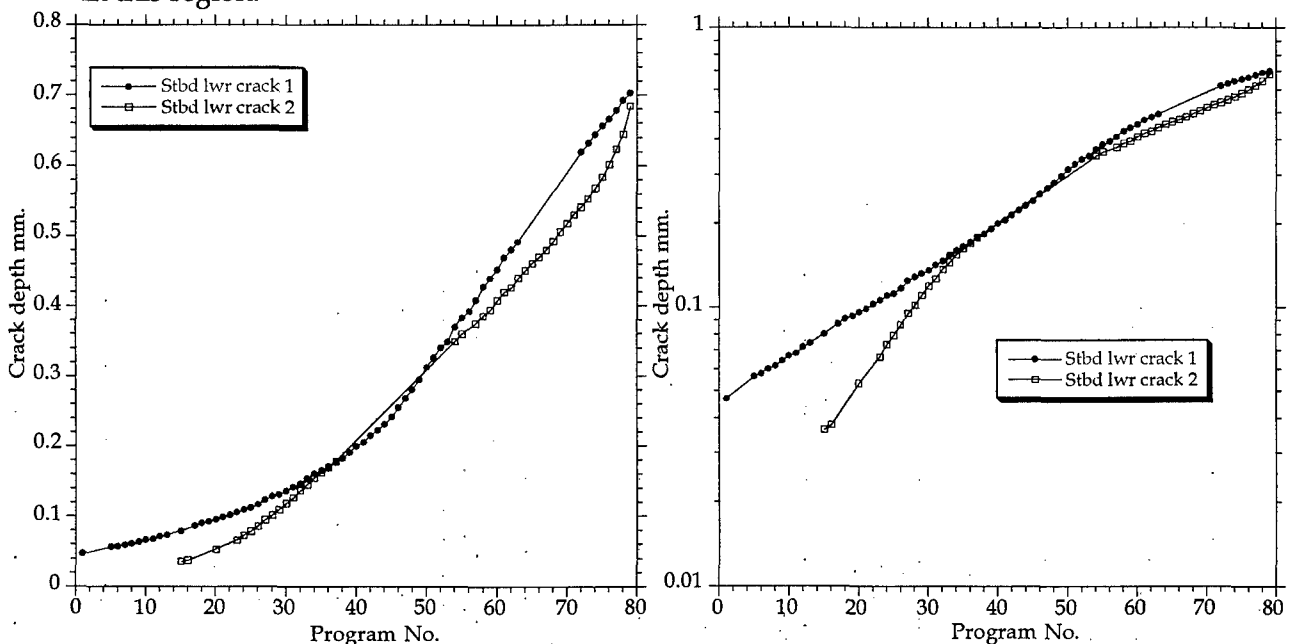
In all cases, the starboard lower wing-attachment hole cracking was found to have initiated from mechanical damage at the edge of the hole. No cracks appeared to have initiated from beneath the IVD as had occurred with the upper holes. The two crack growth curves, plotted on the same axis, are presented in Figure 43. Crack one is consistent with upper-hole cracks in form and the growth nature; the main difference is that this crack appears to have initiated from a large flaw in comparison with the upper-hole cracks. This would be consistent with the initiation occurring from the lip. The lip may have, split to form an initial crack (possibly during formation), or it may have had high residual tensile stress that produced very rapid initial crack growth. The examination of the fracture through the lip region suggested the latter. Relatively high-K type fatigue growth markings could be seen in this region.

Figure 43 A plot of the crack growths from those cracks examined from the starboard lower wing-attachment hole

The second crack grew much faster than the first crack up until about 150 μm . This was probably the result of local tensile residual stresses having an effect to about this depth. Following this region the crack appears to grow at about the same rate as crack 1, probably controlled only by the inherent material crack resistance and the applied loading. This suggests that the severity of the mechanical damage and any associated residual stress was a greater aid to initiation and early fatigue growth (particularly of crack 2) than any other flaw in this area. Flaws in this area that did not initiate a significant crack may have included the etching of grain boundaries (as with the upper holes) and inclusions.

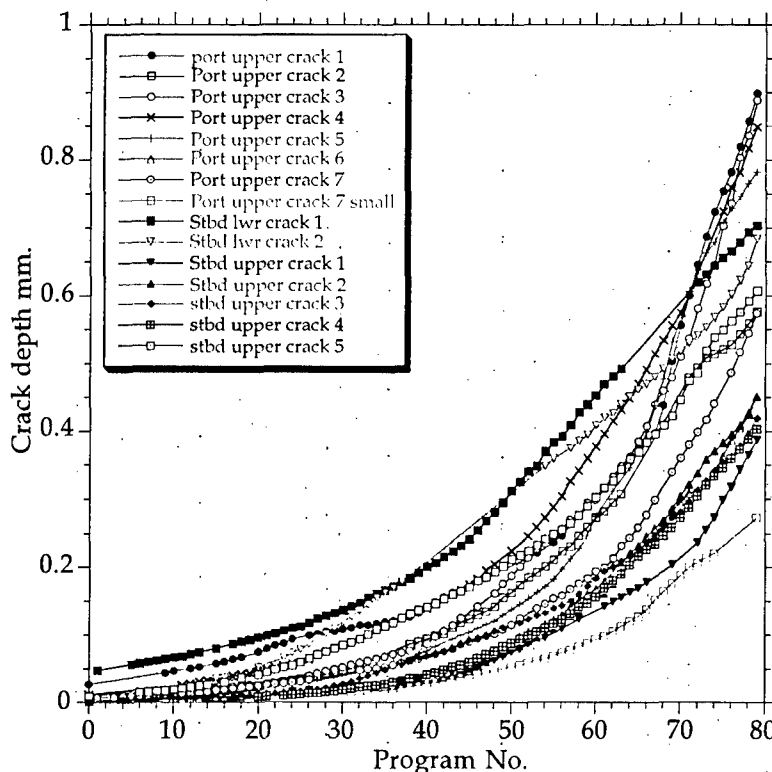
gave a measure of the severity of the stressing for each crack position. The severity is indicated by the slope of the curve or 'b', while 'a₀' indicates the projected 'effective initial crack' size, which may differ from the measured initial flaw size. If the crack growth has a significant amount of linear growth on the log/lin presentation, then the 'b' constant will be a good measure of the likely growth rate in that position, regardless of the type or size of the initiating flaw. In fact, 'b' may be a material constant for a particular spectrum - combining the growth resistance factors which apply to the material. Interestingly the microstructural orientation did not appear to have a significant effect on these results. This leads to the notion that in order to estimate the life of a bulkhead area, both the 'a₀' (initial flaw size) and 'b' (stressing) must be known. Unfortunately the growth data produced to support life estimation is typically a combination of the initial flaw size and the growth to failure, with the final part of this growth distorted by tearing events. This results in difficulties if laboratory specimens do not adequately match the service component; there are significant differences in the initial flaws expected in carefully prepared laboratory specimens, made from material that may be non representative of service components. For instance most of the upper hole fatigue cracks initiated from flaws created by a combination of the IVD etching treatment and the microstructure of the 7050 plate, whereas initiation in laboratory specimens are nearly always found to occur at inclusions or mechanical damage (machining marks). It is noteworthy that inclusions did not initiate the cracking in the upper holes, and that there was evidence that inclusions could arrest very short cracks in these regions, given the large number of cycles that the bulkhead has recieved. Clearly, these differences along with a requirement to produce failures, in laboratory specimens, within a reasonable time, could result in the stressing of laboratory tests being higher than that required to produce the same cracking in the full-scale bulkhead.

Figure 44. All of the crack growth curves plotted on the same axis.

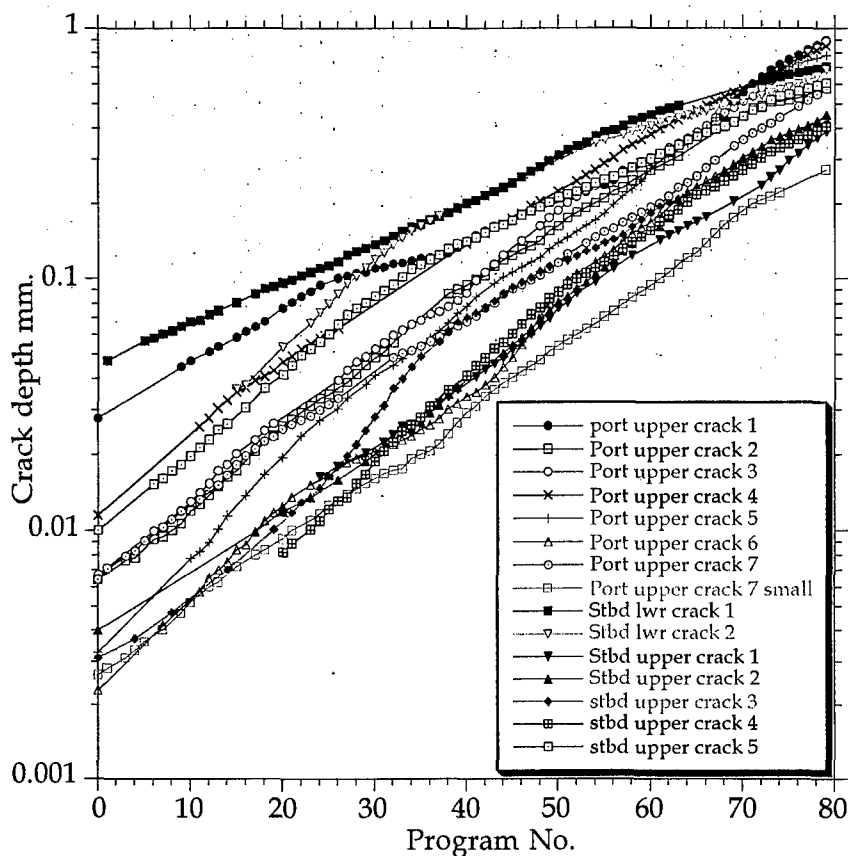
Figure 45. All of the crack growth curves plotted on the same axis- log/lin.
